**AMENDMENT TO ENVIRONMENTAL ASSESSMENT REPORT FOR
PARTNERSHIP INDUSTRIAL CENTER WEST, DATED APRIL 2000**

ENVIRONMENTAL ASSESSMENT

**130-ACRE PLOTNER TRACT
SPRINGFIELD, MISSOURI**

FEBRUARY 2001

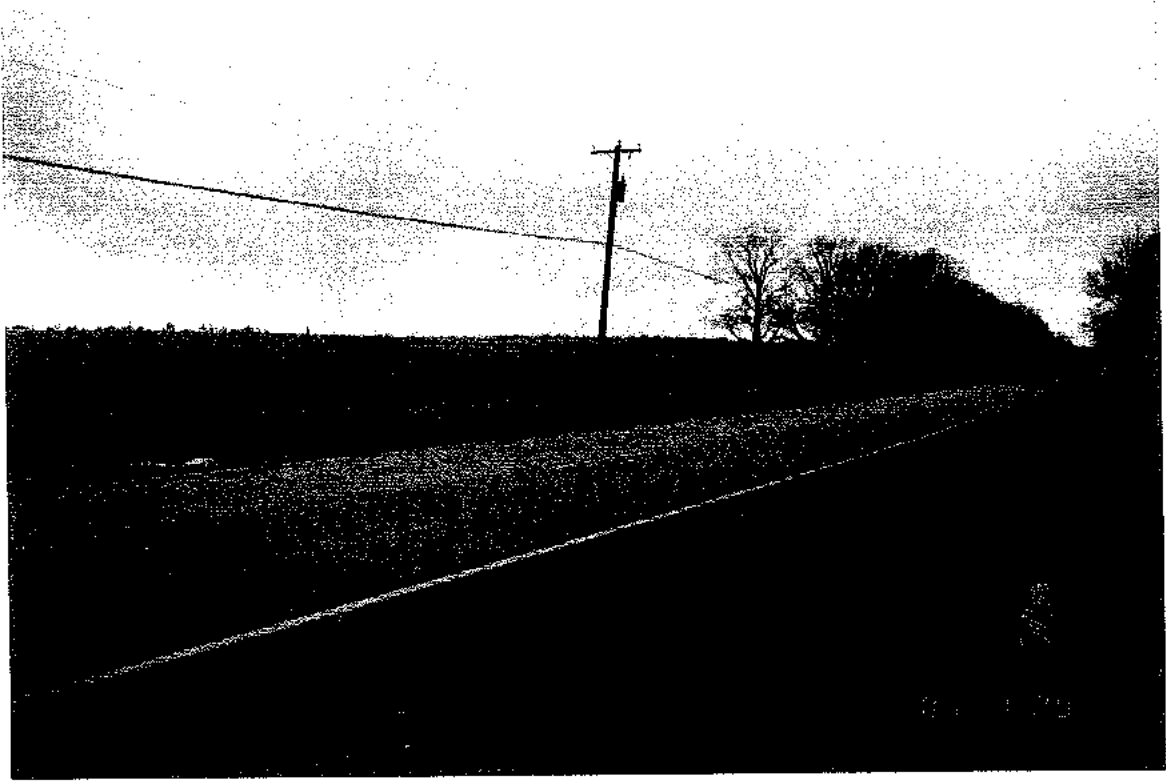
7. North boundary of Property, looking west along State Road EE. Note pole-mounted transformer.

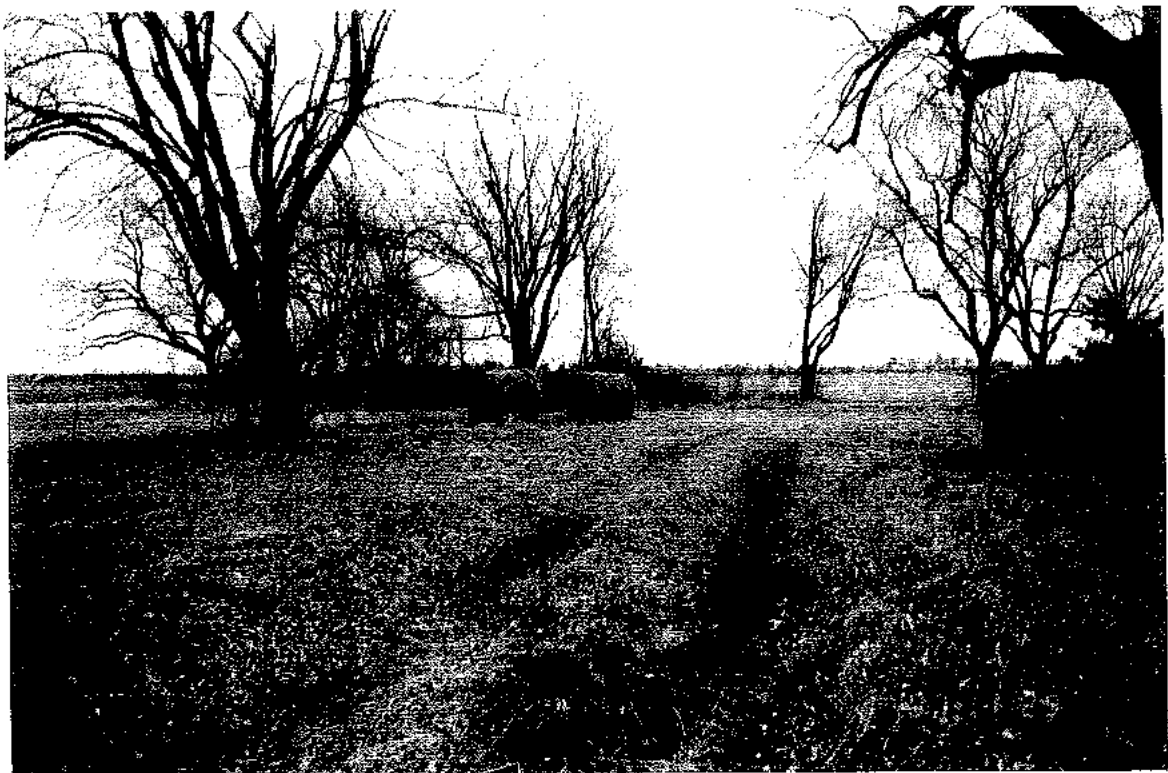
No signs of septic tanks were visible. The former farmhouse may have had either a septic tank or privy for wastewater disposal. The septic tank or privy may still be on the Property near the former farm house vicinity.

The former farmhouse had a well for a water supply. The well still exists on the Property and has not been closed according to Missouri regulations. Details of the well construction are unknown.

12. Former location of farm house along State Road EE. View from road looking south.

No further actions are recommended for the Property. It should be recognized that if the Property is acquired "as is" some costs might be expended for proper closure and abandonment of the water well, removal of any septic tank, and removal of solid wastes in the large brush pile.

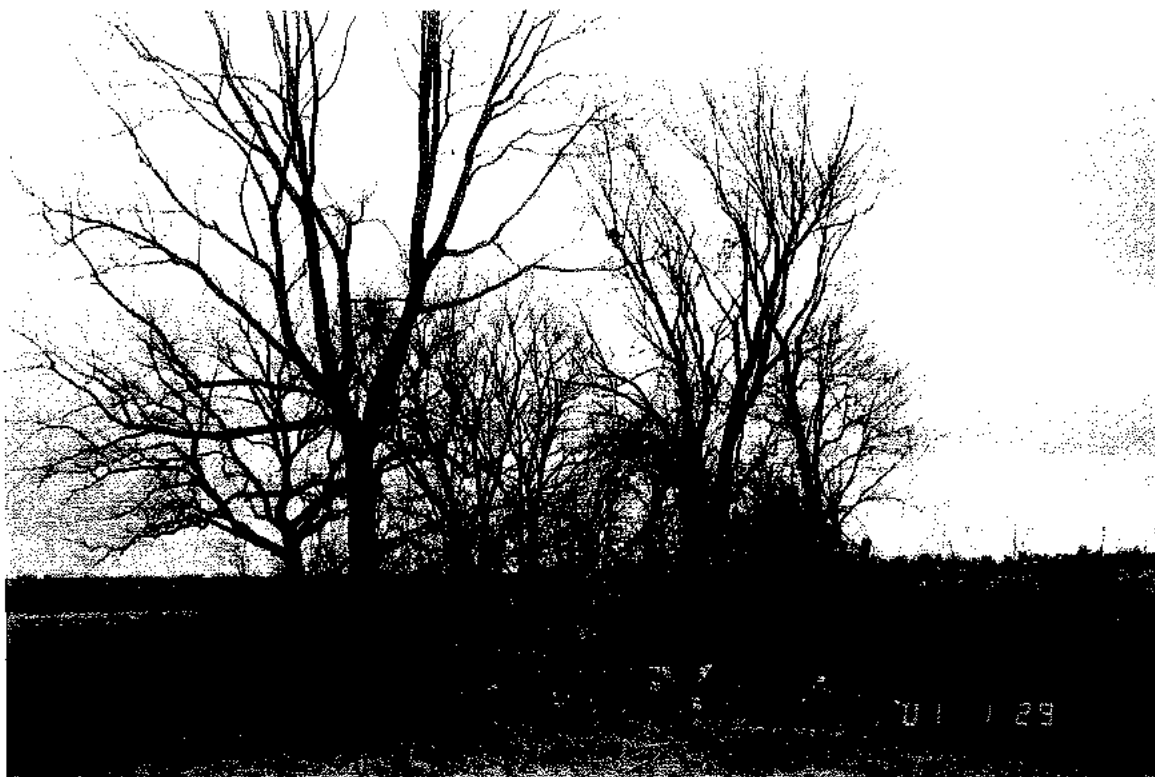
A large brush pile containing some solid wastes was noted along the northern edge of the Property in a small stand of trees. Items that were noted in the brush pile included materials that might have been generated from demolition of the former farmhouse,

including a sink, wood trim, and metal siding.

There were no structures on the Property and no potential asbestos materials from transite siding, floor or ceiling tiles, or piping insulation. No transite siding was noted in the solid wastes in the large brush pile along the northern portion of the Property.

13. View of clump of tree and pile of debris.

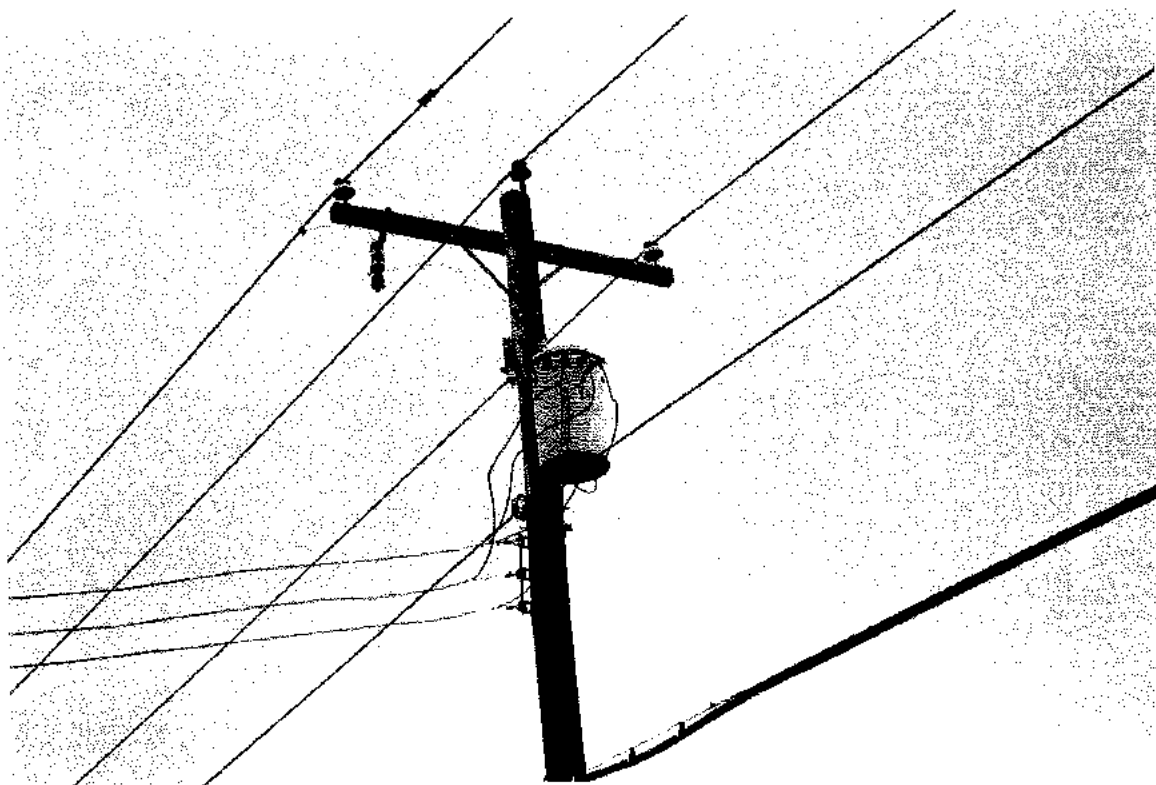
Electrical power for the Property is provided by City Utilities of Springfield (CU). A pole-mounted transformer (#5280B) is located along the northern portion of the Property, adjacent to County Road EE. No leaks or spills were observed beneath the transformer. Transformer records from CU were checked and transformer has not been tested for PCB's. A copy of the transformer PCB data request record is attached.

14. Pole-mounted transformer, Number 25-5280B.
